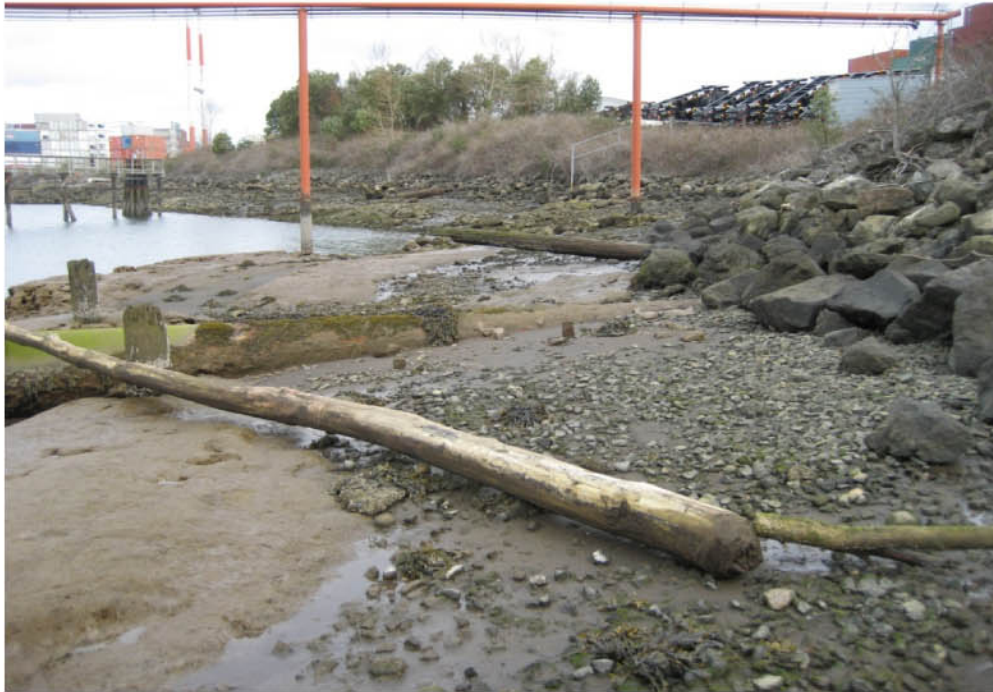
Photo 15: View (looking north) of the north-central and northern portions of the T-108 shoreline; the bank in this area is armored with rip-rap.

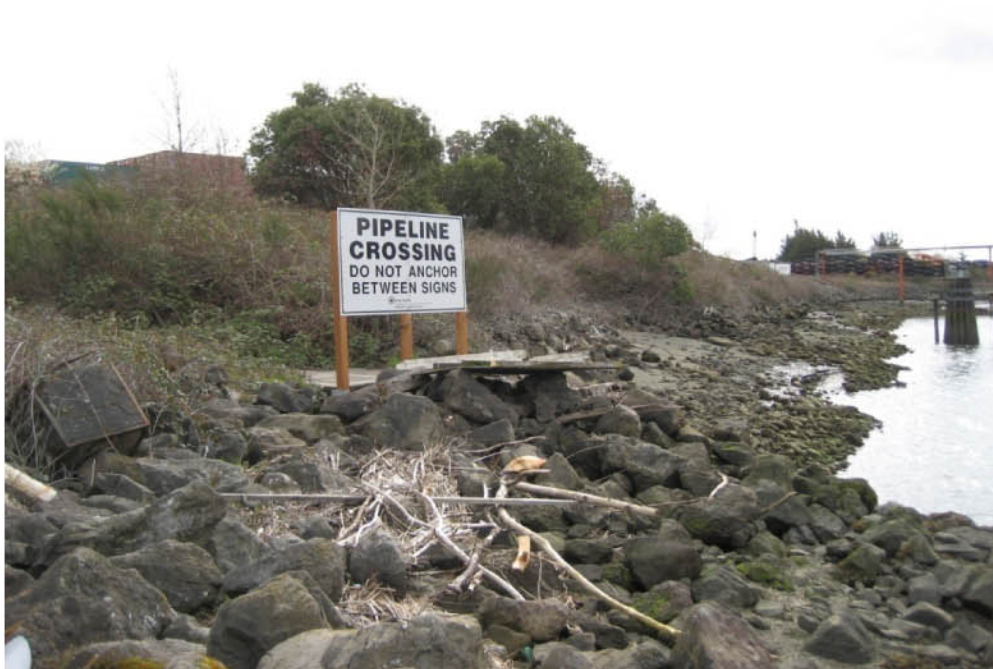
Photo 16: View (looking south from the S Oregon St ROW end) of the northern portion of the T-108 shoreline. The Duwamish/Diagonal CSO/SD and EOF outfalls are nearby, and the location of the Duwamish Siphon is indicated by the sign.
